Chapter 3 Assessment of Existing Situation

3.3 *Summary of issues identified from field investigation*

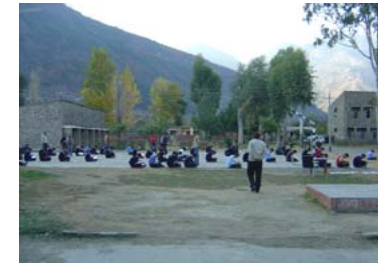
- Some ITIs were found to be located at far away distance from the habitations or industries, for example Samshi ITI of Himachal Pradesh is located at a remote area, however accessibility is good.

ITI Shamsi located on steep slope

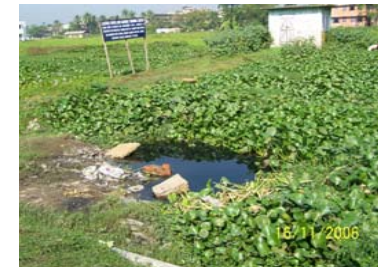
- ITI Guwahati is located in a low-lying area resulting into stagnation of water throughout the year and water logging is evident in the playground for students.

Playfield converted in to wetland at ITI Guwahati

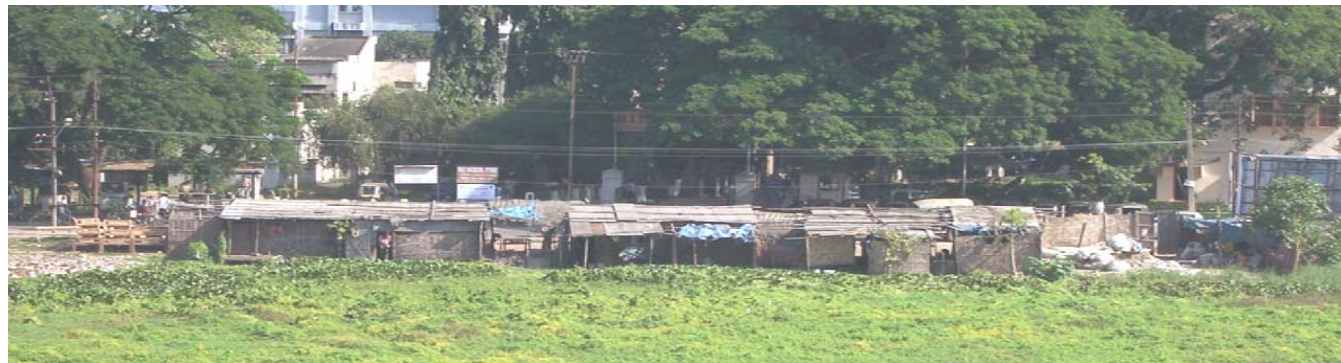
- Boundary wall provides a sense of security and compactness of any educational campus. This important aspect is ignored in most of the ITIs. ITI Panjim is directly located on the urban street. ITI Durgapur boundary wall was found to be broken and encroached upon. But the case of ITI Guwahati is an eye opener in this context as part of Campus (approximately 4 Bighas) was encroached upon and the IMC was bound to hand over the area to the encroachers. However no other ITI was found to have any encroached area as of today.

Encroachment in ITI Guwahati

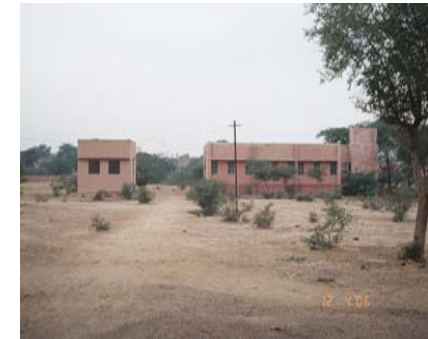
- Green space or open space in an educational campus gives a special ambience but it was found that most of the ITIs are not having ample green or open space except in ITI Vishakhapatnam. The ITI at Durgapur, Ankleshwar, Bikaner and Gandhinagar represents poor maintenance and landscaping.

No green space– Bikaner

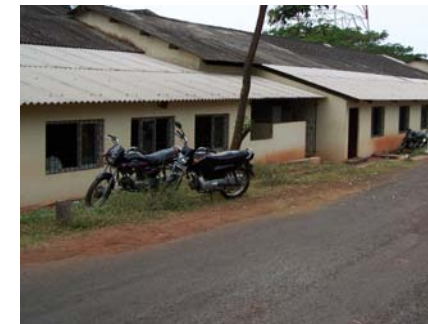
- No defined parking area was found in most of the ITIs, leading to poor accessibility. In ITI of Goa, Durgapur and Guahati allotted parking space was found, however it is not at all sufficient for the number of vehicles.

Lack of Parking Space –ITI, Goa

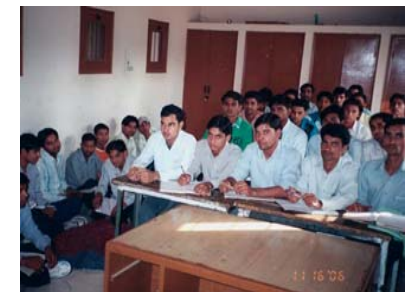
Area of classroom per student (in sq. mtrs.) was found varying from 0.43 in ITI Vishakhapattanum to as high as 3.47 in ITI Goa. The average area per student in classrooms was found to be 1 to 2 sq. mtrs. per student. However due to ongoing construction work, classrooms are some time over crowded as shown in the picture beside at ITI Hissar .

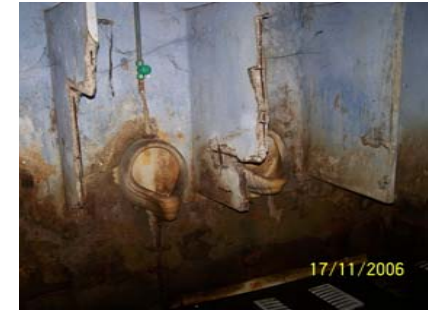
Sanitation block at ITI Durgapur

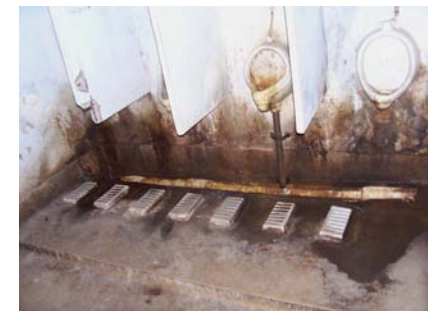
Sanitation block at ITI Durgapur

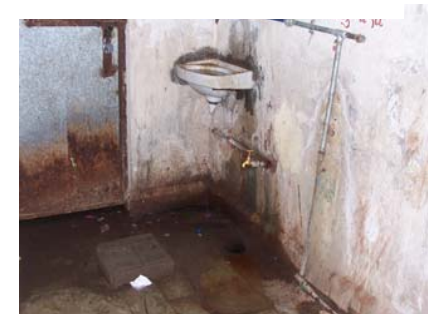
Location of drinking water facility at ITI Ankleshwar

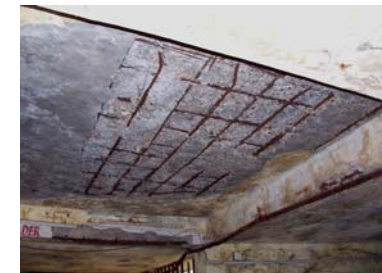
- As far as long terms maintenance is concerned, in general all major repair works are carried out by PWD. This arrangement often delays the process of regular up keep. For example Ankleshwar ITI is an exceptional case of disrepair - the RCC slabs show high amount of corrosion and spalling of concrete in almost all the buildings. The toilets and other services are also in a very bad state of maintenance. The ITI at Durgapur also has shows a very poor state of maintenance and repair.

Roof of classroom at ITI Ankleshwar

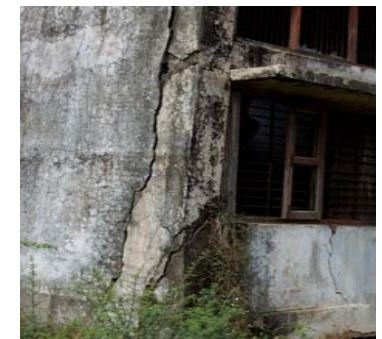
Cracked wall at ITI Ankleshwar

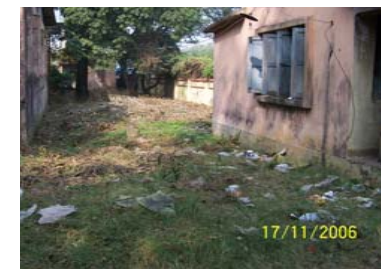
Status of campus maintenance at ITI Durgapur

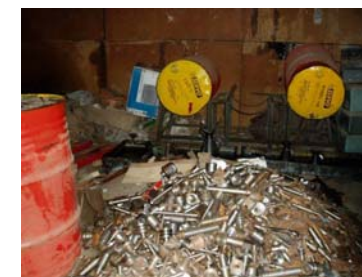
Hazardous materials—such as laboratory chemicals, chemical by-products, chemical handling supplies, paints, and solvents—can cause pollution and present risks to health, safety, and the environment. The improper use and disposal of hazardous chemicals have consequences on both the health of those who handle the material and those whose water, air, and land may be polluted by leaks, spills, and volatile emissions. However, proper storage and disposal of hazardous solid waste was not found in any ITI. In most of the ITI, hazardous solid waste was found dumped in an open place with out any signage. Storage of different waste material like broken furniture, old table cloths, roofing material was found in corners of classrooms.

Storage of Hazardous waste
