Chapter 3 Assessment of Existing Situation

3.3 *Summary of issues identified from field investigation*

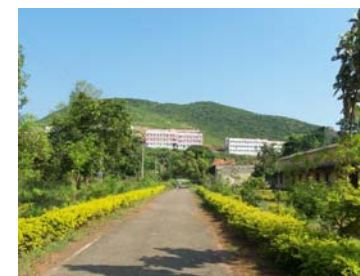
The workshops, classrooms were also very well maintained. The toilet blocks were clean and well maintained though the materials used were dated indicating to the fact that they were maintained properly all through. The trades like carpentry, welders, plumbers do some part of the routine maintenance work, this subsidises the costs of maintenance as well as the training giving the additional benefit of building remaining well maintained. The plumbing trade students maintained the taps and other devices, for major repairs the trainer would help the students and direct them.

The painting trade students whitewash the walls and often the trade does various paintings on the walls also making the campus more lively. The students are also participating in the gardening and other campus activities, which has resulted in a green and clean campus.

Status of campus maintenance at ITI Vishakhapattanam

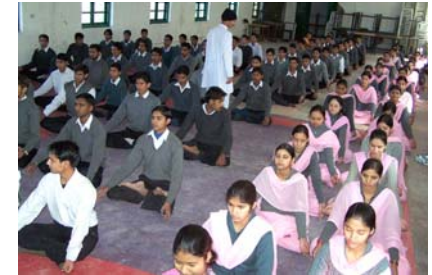
- Holistic Personality development courses like Yoga being practiced by ITI Solan, as can be seen from the picture beside.
